SAFETY ALERT

Hand Trolley de-rails on the Up Poplar Line at OOC

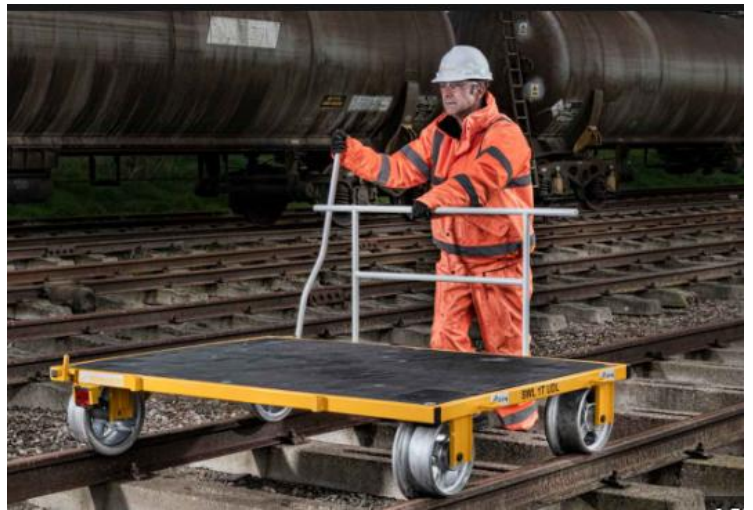
On the 17th Dec, 2023 at 04:10, a hand trolley being pushed on the Up Poplar Line derailed at 8122A points. The trolley was moved from the Down Poplar to allow a maintenance RRV through. The team had left the trolley on this line when work could not be continued. They were pushing the trolley back to egress when the incident occurred.

- The Trolley Op and COSS did not inspect the points to ensure they were normalised and set in the correct direction before proceeding through
- A third-party team working in this area and responsible for ensuring the points were normalised did not do so before leaving site the shift prior.
- The Point Protocol was not observed as there were no 'Til Dawn' lamp placed at the points.

- Remember to check all points are set in the right position for any trolley or RRV movement
- Take 5 and follow Colas Work Safe Procedure when site conditions don't seem safe as failure to do so could lead to unplanned event
- Always complete the Points Operator Points Movement form liaising with the ES when your duty is PO.

- Do a Worksite/Dynamic risk assessment and agree with the team on the safest method of work
- Liaise with third parties working in the vicinity to resolve hazardous conditions
- Observe the Points Protocol (NR/L3/OPS/255) and ensure Tildawn lamps are placed at points to remind safety critical staff
